Monitoring Data Record

Project Title: U-2524AB (Site 3) COE Action ID: 200321137  
 Stream Name: UT #3 Reddicks Creek DWQ Number: 030909  
 City, County and other Location Information: Greensboro Western Loop, Guilford Co.  
Sta. 34+00 to Sta. 37+10 -L-  
 Date Construction Completed: Water was turned into the stream on June 2005 and planted  
January 2007. Monitoring Year: ( 2 ) of 5  
 Ecoregion: \_\_\_\_\_ 8 digit HUC unit 03030002  
 USGS Quad Name and Coordinates: \_\_\_\_\_

# UT #3 Reddicks Creek

Year 2 Winter – January 2008

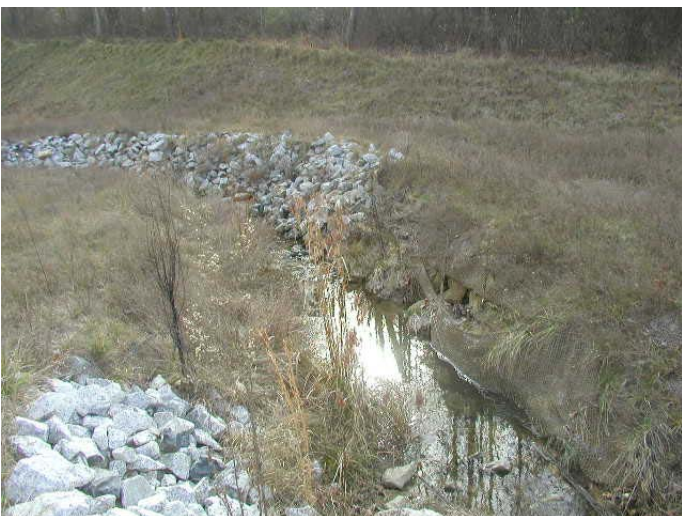
Photo Point #6 (Upstream)

The UT #3 Reddicks Creek stream relocation is stable for the Year 2 winter evaluation. There was some minor bank scouring noted on the left bank at Photo Point #6 (upstream). NCDOT will continue to monitor this stream relocation.

1/16/08	PP#6 Sta. 36+80	Station Number	Station Number	Station Number	Station Number
Structure Type					
Is water piping through or around structure?					
Head cut or down cut present?					
Bank or scour erosion present?	Minor Bank Scouring
